USB socket-outlets scrutinised

Our attention has now turned to new types of product that are becoming increasingly popular — 13 A socket-outlets, extension leads and adaptors that incorporate USB power supplies.

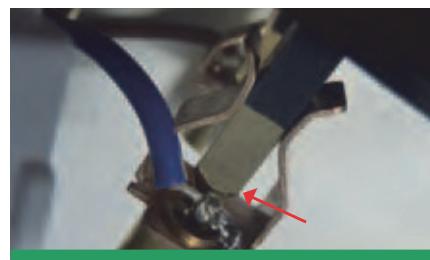
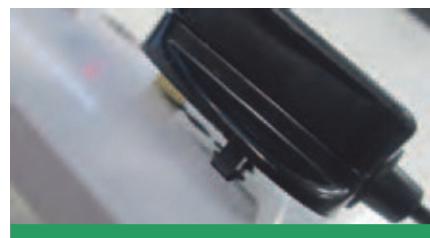
Fig 2. Soldered connections in the accessory prevented the test plug being fully inserted

In another sample, the internal conductors used to power the PCB were soldered onto the live (line and neutral) socket contacts into which the live pins of 13 A plugs should fit.

However, as Fig 2 shows, the soldered connections prevented the test plug from being fully inserted, creating a potential source of overheating. Furthermore, should such a solder-only power connection fail, displacement of the wire could result in an earth fault, short-circuit, or mains voltage appearing at the USB charger output, creating a risk of electric shock and/or fire.

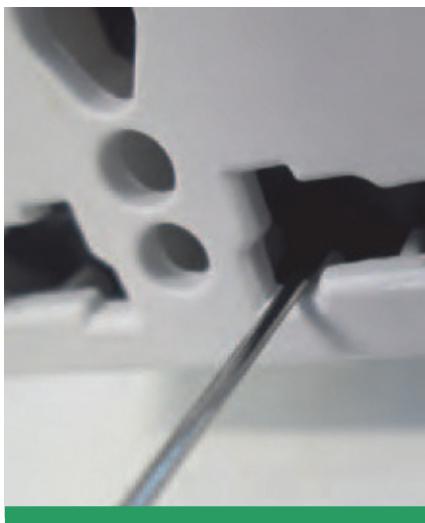
Fig 3. Access to live parts

One sample, No. 7, failed this test due to poorly fitting shutters over the apertures to the live contacts in the socket-outlet, as shown in Fig 3. In fact, as shown in Table 1, this particular sample performed worse of all, failing 8 of the 12 test criteria.

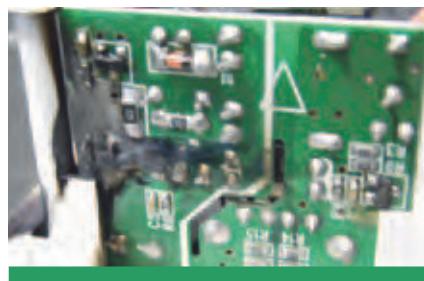
Fig 4. Visible damage to one PCB caused by load testing

Two samples failed this testing. Sample No. 3 failed quietly, simply providing no output at the end of the test period. In contrast, Sample No. 7 failed with dramatic results after approximately 1.5 hours which, as Fig 4 shows, damaged the PCB extensively. A surface mounted resistor ruptured and both USB socket wires were blown off.

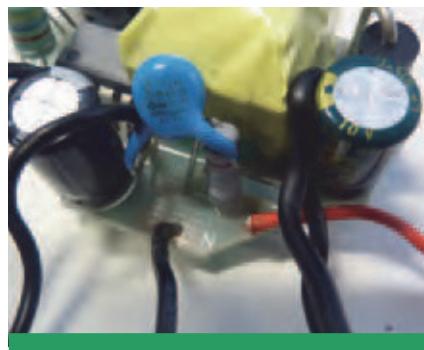
Fig. 5 Point at which Sample No. 6 failed the electric strength test

All but one of the samples passed the standard dielectric strength. The one that failed did so at just 800 V d.c. A burn test later revealed that arcing had occurred between the fusible resistor and the tail of a capacitor which, as can be seen in Fig 5, had been in direct contact with one another.
