Screening Report

Report: 071-75924520-201 **Date:** 18/12/2013

Product: Electrical Accessory **ESC Sample Number:** 5

Summary: TÜV SÜD Product Service was commissioned by The Electrical Safety Council to evaluate an Electrical Accessory (see figure 1). The aim of the assessment is to assess the product against the clients Safety Screening Test Plan.

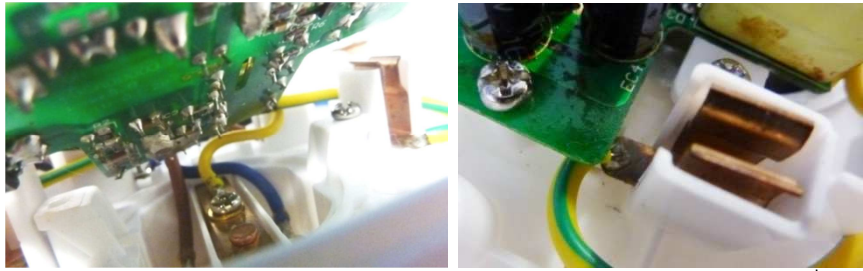
Constructional Quality	<input type="checkbox"/> -Pass <input checked="" type="checkbox"/> -Fail
Comments	<p>The output (SELV) circuit was not found to be adequately separated from the input circuit. The live parts of the SELV circuit were found to be in direct contact with the protective earth. The earthing conductor to the L/H side was also noted to be in close proximity to the SELV circuit with 3.5mm clearance distance measured.</p>

<p>There was insufficient marking to the internal wiring to verify any 3rd party approvals.</p>

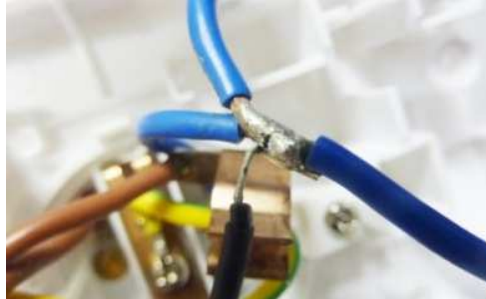
Constructional Quality	<input checked="" type="checkbox"/> -Pass <input type="checkbox"/> -Fail
Comments	<p>The connections to the conductors and the PCB were all found to be mechanically secured and soldered; however the intermediate wiring connections (multiple) were found to be retained by soldering with heat shrink sleeving used as an additional form of retention. It is recommended that a mechanical form of security is employed (i.e. terminal block).</p>

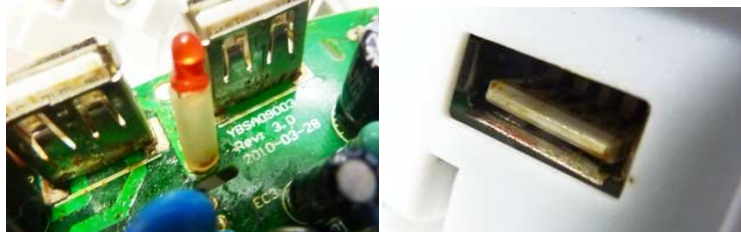
<p>Areas of verdigris to the copper conductors and rusting to the USB sockets (internal & external) were noted.</p>

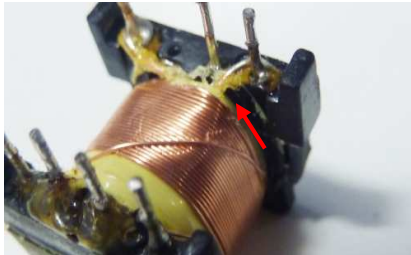
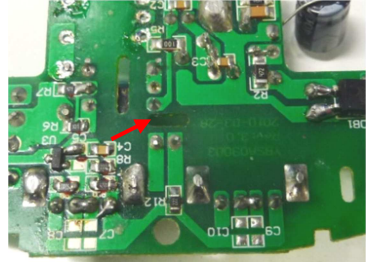
Creepage Distances, Clearances & Distances Through Insulation (BS EN 61558-1, Clause 26)	
Constructional Quality	<input type="checkbox"/> -Pass <input checked="" type="checkbox"/> -Fail
Comments	<p>The secondary transformer winding was of a triple-insulated construction. This would usually provide an adequate barrier from the primary winding; however the tails were left exposed and as such, negate the purpose of the insulation. The minimum creepage / clearance distance measured between the windings (0.7mm) and between the primary and secondary sides of the circuit (3.1mm) did not meet the requirement of the standard >5mm.</p> <div style="display: flex; justify-content: space-around;">

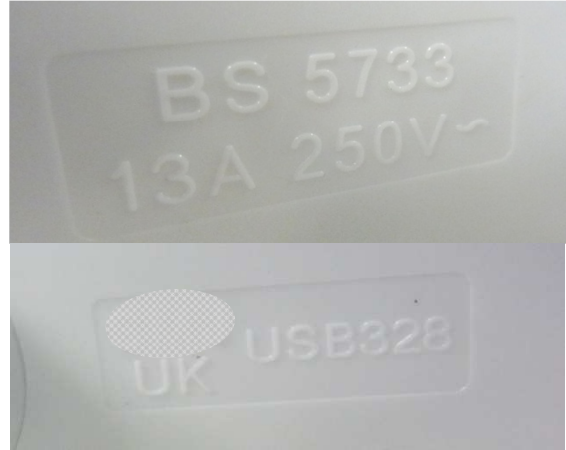
Markings

Findings	
Markings/Warnings (BS 5733, Clause 8)	
Marking of Product	<input checked="" type="checkbox"/> -Inadequate <input type="checkbox"/> -Poor <input type="checkbox"/> -Adequate <input type="checkbox"/> -Good <input type="checkbox"/> -Very Good <input type="checkbox"/> -N/A
Comments	<p>The product was marked with a model reference, input ratings (covering the BS 1363 sockets only) and distributor trademark. There were no electrical ratings for the USB ports. The WEEE logo and CE marking were also missing. BS 5733 was stated; however BS 5733/A should be stated as it a portable accessory.</p> <p>The packaging's carded insert stated that the product is ideal for iPods, telephones, mobile and hairdryers; however there was no safety advice provided to cover either the sockets or the USB outputs.</p>
Markings/Photo	<input checked="" type="checkbox"/> -Yes <input type="checkbox"/> -No <i>If yes see last page of report</i>

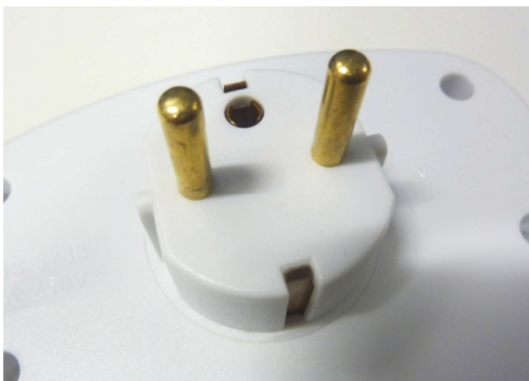
Plug Face

CE Marking	<input type="checkbox"/> -Yes <input checked="" type="checkbox"/> -No
External Construction	
Product Build Quality	<input checked="" type="checkbox"/> -Pass <input type="checkbox"/> -Fail
Comments	The external construction was of an adequate standard however the mouldings were considered to be of a lesser quality compared to similar products already on the market. No sharp edges, burrs or pinch points were found.
Accessibility of Live Parts (BS 5733, Clause 11.2)	
Constructional Quality	<input type="checkbox"/> -Pass <input checked="" type="checkbox"/> -Fail
Comments	The casings had been adequately secured with screws (not tamperproof). The 1.0mm test pin did not access any live parts with the shutter closed.
Terminals & Terminations (BS 5733, Clause 14)	
Constructional Quality	<input checked="" type="checkbox"/> -Pass <input type="checkbox"/> -Fail
Comments	The product was supplied with a class I European (Schuko) plug face. A check revealed that some resistance was felt when inserting / removing a number of BS 1363 approved plugs into the sockets; however the earth pin engaged before the live / neutral pins.

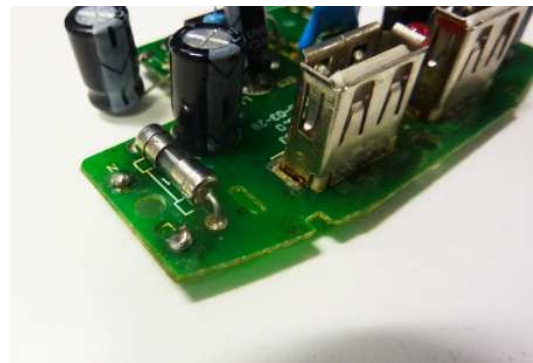
Fuse

</div>
Short Circuit, Overload and Thermal Protection (BS EN 61558-1, Clause 15)	
Constructional Quality	<input checked="" type="checkbox"/> -Pass <input type="checkbox"/> -Fail
Comments	A 1A glass fuse was suitably fitted to the primary side of the circuit. There was no thermal protection present. Although not a requirement it is recommended that a link or similar is incorporated into the circuit.
