# Counterfeit and imitation Apple chargers 98% Safety Test Failure Rate

### **Counterfeit and imitation Apple chargers** 98% Safety Test Failure Rate

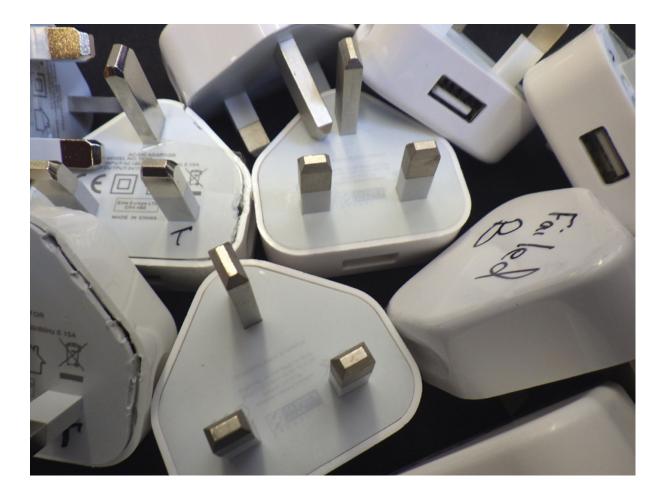
Only one charger passed the mechanical tests and subsequently managed to fit the pin gauge. Many of the chargers that failed the test suffered severely bent and twisted pins and for four samples, the pins snapped off. Broken pins could be left exposed inside the mains socket, again representing a **significant risk of electric shock.**

Figure 9. Snapped plug pins following mechanical strength tests

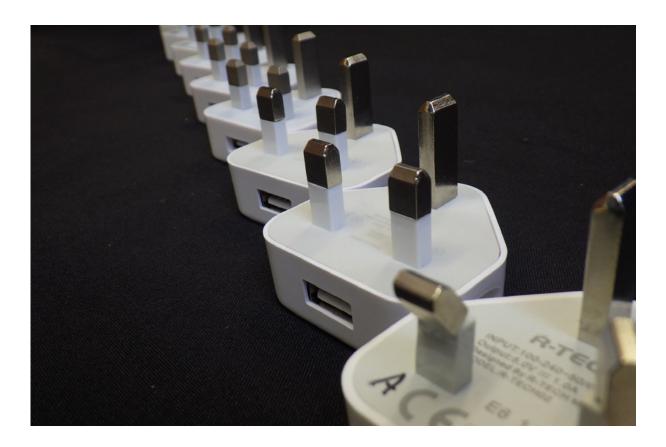
There are a number of quick checks that can be done without specialised equipment to see if an Apple charger of the type discussed in this report is genuine. Whilst most are easy, some are greatly assisted by the person inspecting being familiar with the genuine product or having one available to compare and contrast.
