# Test Report

Report No	2390/7438735	This Report consists of 18 pages
Client	Electrical Safety Council 18 Buckingham Gate London SW1E 6LB	
Authority & date	Quotation Acceptance dated 12 August 2009	
Items tested	Ten Direct plug-in mains power supply units Equipment Reference Number 10109544	
Specification	Testing to limited clauses of:- EN 61558-1:1997 EN 61558-2-17:1997 see within for details	
Results	Did not comply See comments	
Prepared by	M T Dyer

Ten direct plug-in mains power supply units were tested to limited clauses of EN 61558-2-17:1997 (Safety of transformers, power supply units and similar – particular requirements for switch mode power supplies).

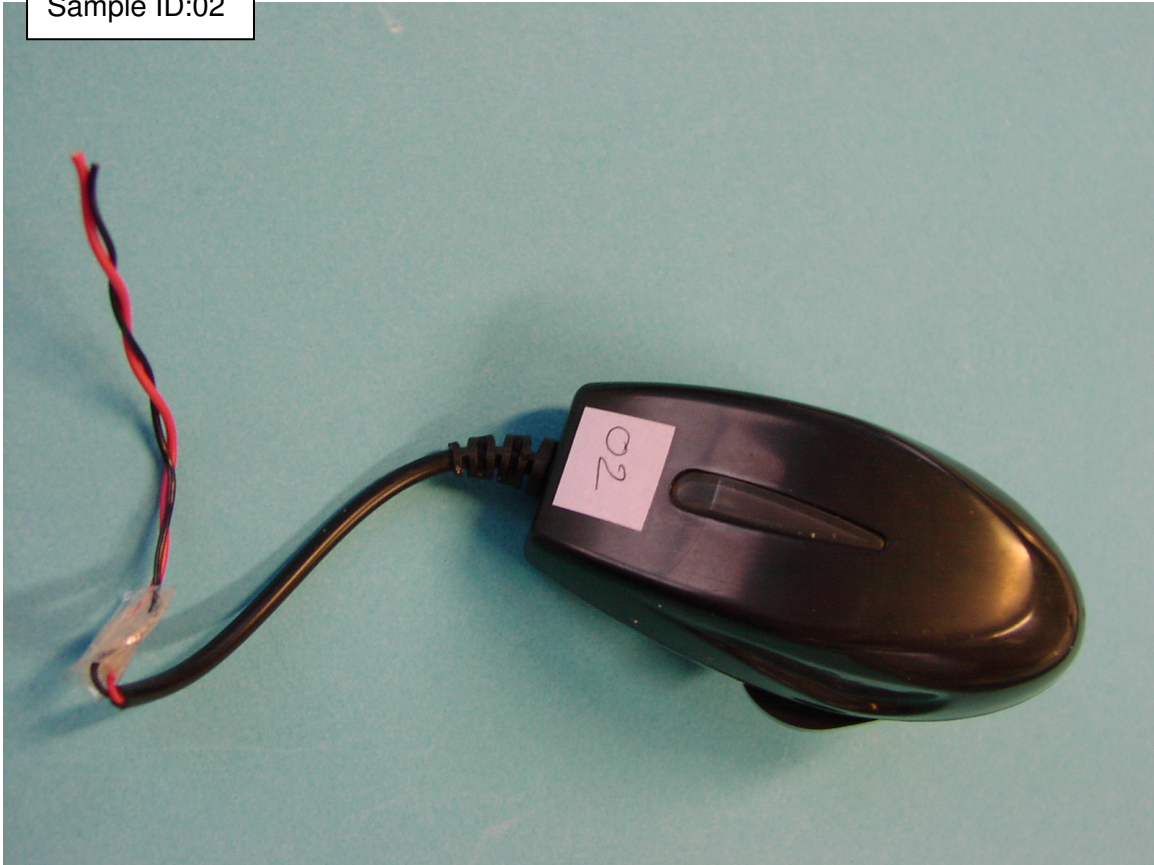
Sample ID:02

As received observations: None.

The measured creepage distance between Live and Neutral before any fusing was 2.1mm and the measured clearance distance was 1.8mm, the minimum requirement is 2.4mm.

The submitted power supply unit ID02 failed to meet the requirements of the clauses tested, as detailed above.

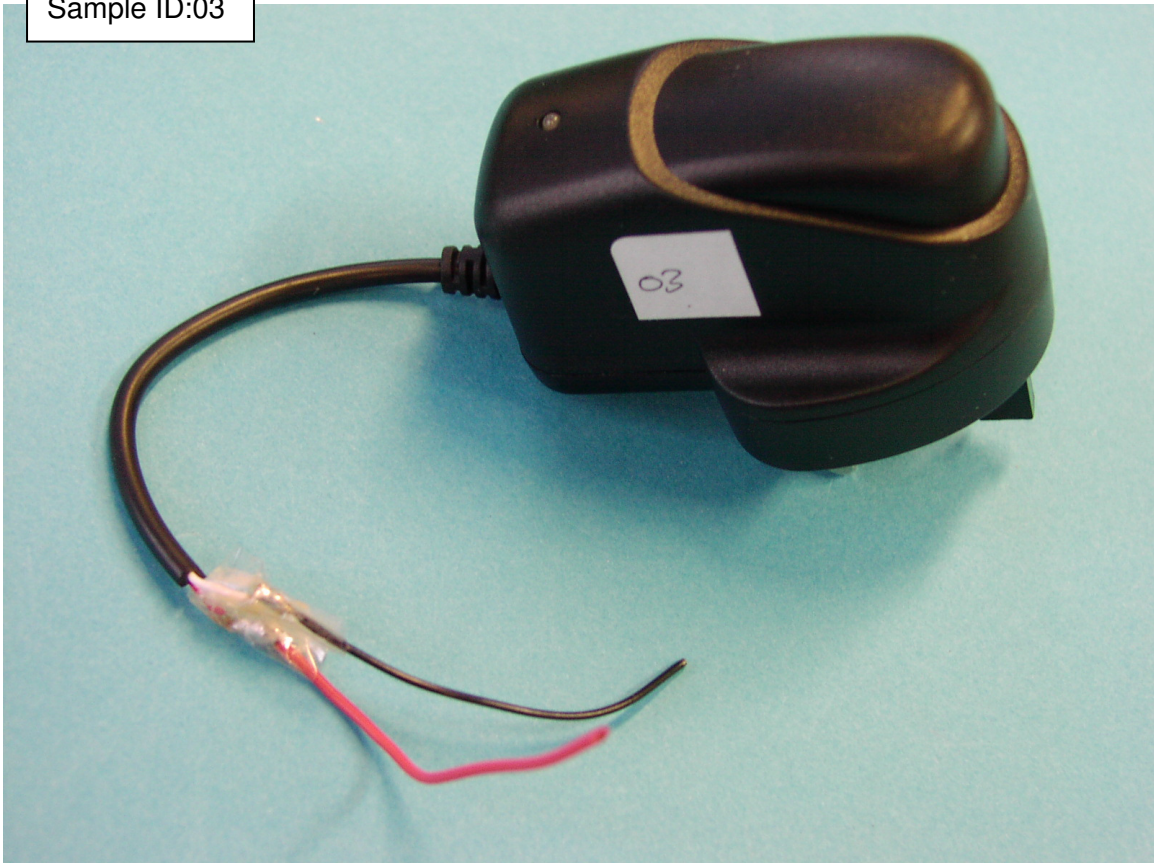
Sample ID:03

As received observations: None.

From live parts to the secondary circuit on the PCB, the measured creepage distance was 4.9mm and the measured clearance distance 4.5mm.

The submitted power supply unit ID03 failed to meet the requirements of the clauses tested, as detailed above.

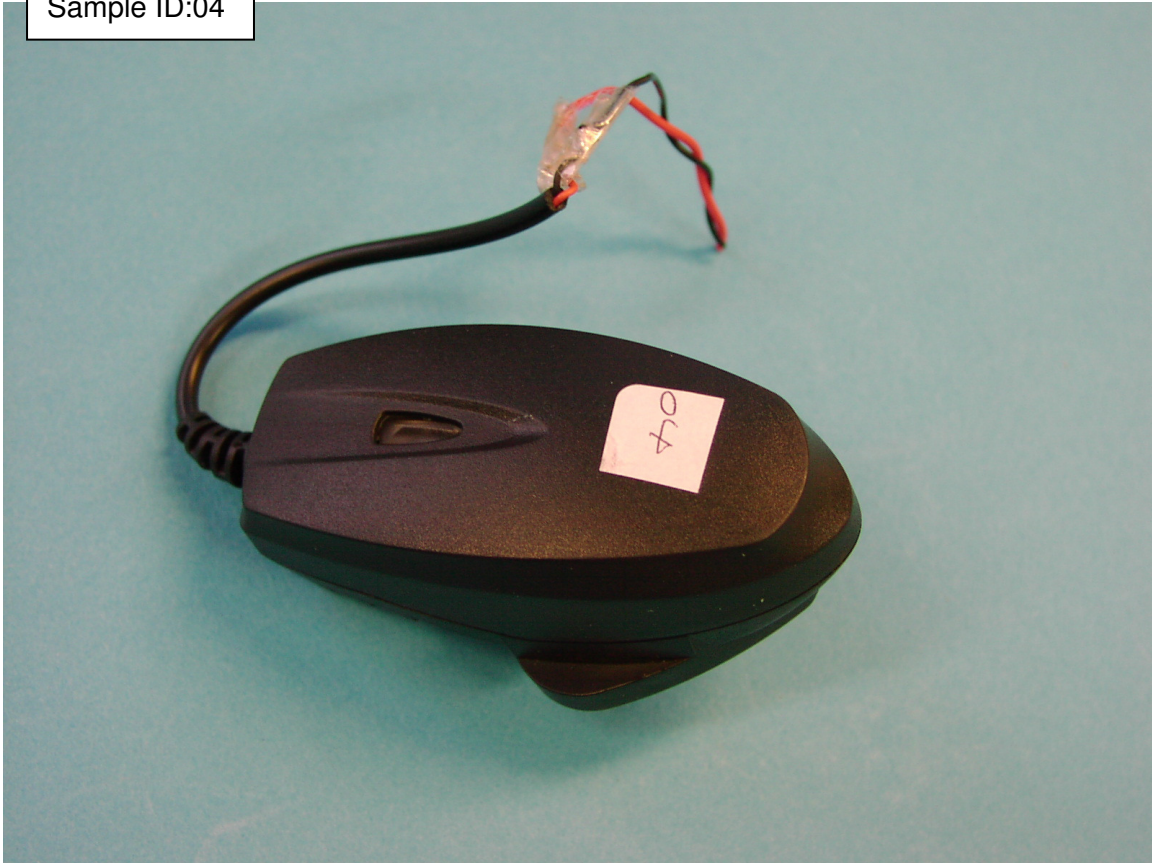
Sample ID:04

As received observations: Plastic Earth Pin had broken off.

The measured creepage/clearance distance from live parts to accessible parts (the body of the PSU) was 3.8mm.

The measured creepage distance between Live and Neutral before any fusing was 2.2mm and the measured clearance distance was 1.5mm, the minimum requirement is 2.4mm.

The submitted power supply unit ID04 failed to meet the requirements of the clauses tested, as detailed above.

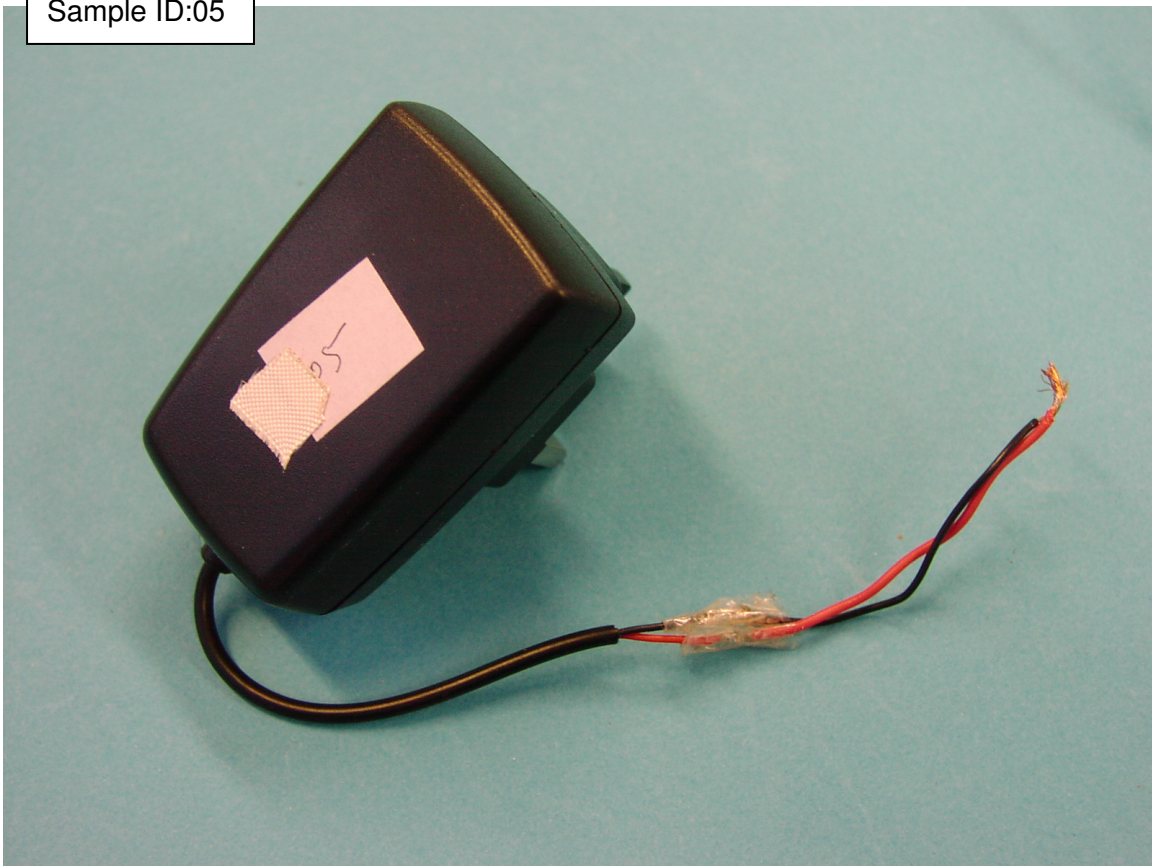
Sample ID:05

The unit was not marked with a manufacturer name or trade mark as required by sub-clause 8.1i).

The unit met the dielectric strength test requirements of this clause with 3,640V~ applied between hazardous live parts and the power supply body with no breakdown. However with the dielectric strength test applied between input and output circuits, the insulation broke down at 2,000V~.

The Live and Neutral wires connecting the PCB to the plug pins were attached to the plug pins by solder only, with no secondary securement. Should a wire break free, its movement could result in a hazardous mains voltage being applied to the low voltage secondary circuit.

The measured creepage/clearance within the mains transformer (live parts to secondary circuit) was 1.0mm.

The measured creepage/clearance distance between Live and Neutral before any fusing was 0.6mm, the minimum requirement is 2.4mm.

The Y capacitor across primary to secondary barrier was marked '472 2kV' – no marking was present to indicate that it is a Y1 capacitor.

The submitted power supply unit ID05 failed to meet the requirements of the clauses tested, as detailed above.

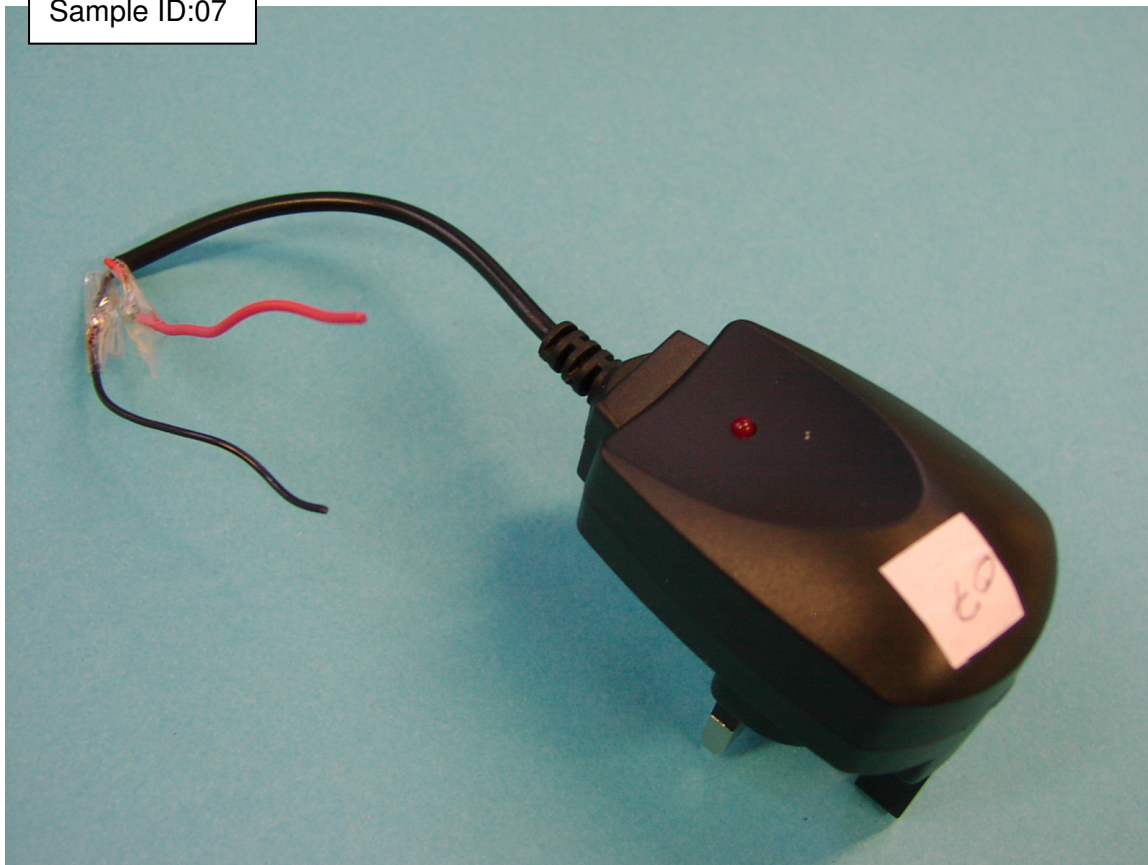
Sample ID:07

The unit was not marked with a manufacturer name or trade mark as required by sub-clause 8.1i).  
The unit was not marked with a model or type reference as required by sub-clause 8.1j).

The unit met the dielectric strength test requirements of this clause with 3,640V~ applied between hazardous live parts and the power supply body with no breakdown. However with the dielectric strength test applied between input and output circuits, the insulation broke down at 3,000V~.

The Live and Neutral wires connecting the PCB to the plug pins were attached to the plug pins by solder only, with no secondary securement. Should a wire break free, its movement could result in a hazardous mains voltage being applied to the low voltage secondary circuit.

The measured creepage/clearance within the mains transformer (live parts to secondary circuit) was 1.4mm.

Under output short circuit test – external bench over current trip operated due to excessive current flow. Internal component damage observed.

The submitted power supply unit ID07 failed to meet the requirements of the clauses tested, as detailed above.

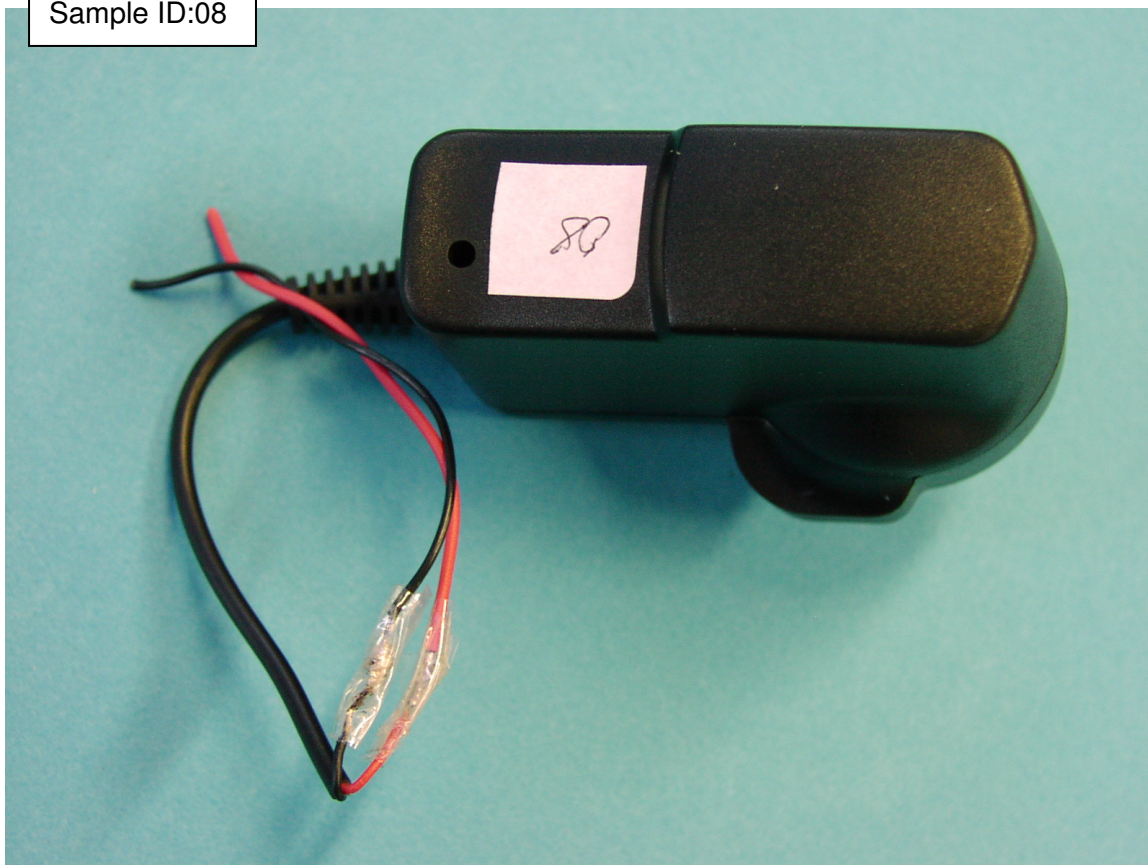
Sample ID:08

As received observations: One of the enclosure securing screws was missing with the thread for this screw damaged.  
The Plastic Earth Pin was broken off.

The unit was marked 'class 2' with no class II symbol as required by sub-clause 8.11).

The unit met the dielectric strength test requirements of this clause with 3,640V~ applied between hazardous live parts and the power supply body with no breakdown. However with the dielectric strength test applied between input and output circuits, the insulation broke down at 2,500V~.

The Live and Neutral wires connecting the PCB to the plug pins were attached to the plug pins by solder only, with no secondary securement. Should a wire break free, its movement could result in a hazardous mains voltage being applied to the low voltage secondary circuit.

The measured creepage/clearance within the mains transformer (live parts to secondary circuit) was 0.7mm.

Under output short circuit test – external bench over current trip operated due to excessive current flow. Internal component damage observed.

The submitted power supply unit ID08 failed to meet the requirements of the clauses tested, as detailed above.

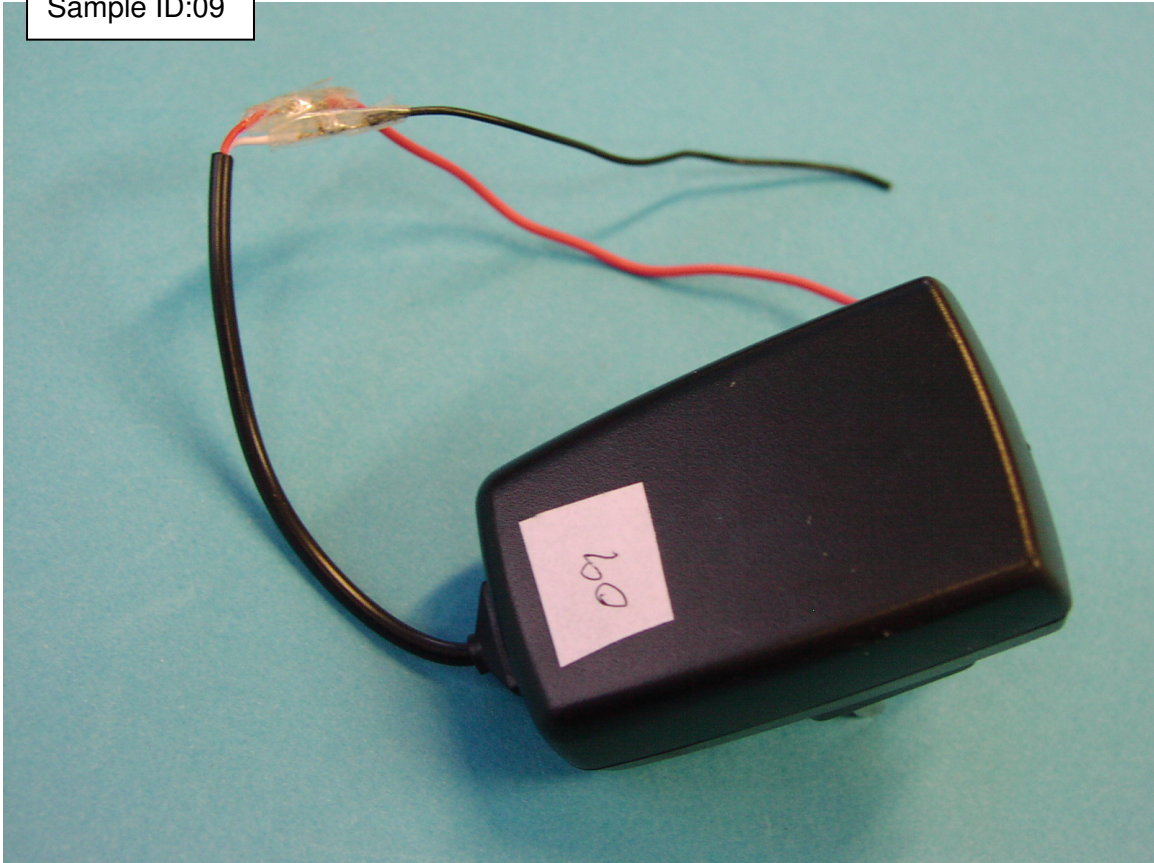
Sample ID:09

The unit met the dielectric strength test requirements of this clause with 3,640V~ applied between hazardous live parts and the power supply body with no breakdown. However with the dielectric strength test applied between input and output circuits, the insulation broke down at 3,640V~, the sample under test did not withstand the applied voltage for 1 minute. The unit passed this test at 3,000V~ for 1 minute.

The Live and Neutral wires connecting the PCB to the plug pins were attached to the plug pins by solder only, with no secondary securement. Should a wire break free, its movement could result in a hazardous mains voltage being applied to the low voltage secondary circuit.

The measured creepage/clearance within the mains transformer (live parts to secondary circuit) was 1.1mm.

No markings on the capacitor across primary to secondary barrier – this is required to be a Y1 capacitor.

The submitted power supply unit ID09 failed to meet the requirements of the clauses tested, as detailed above.

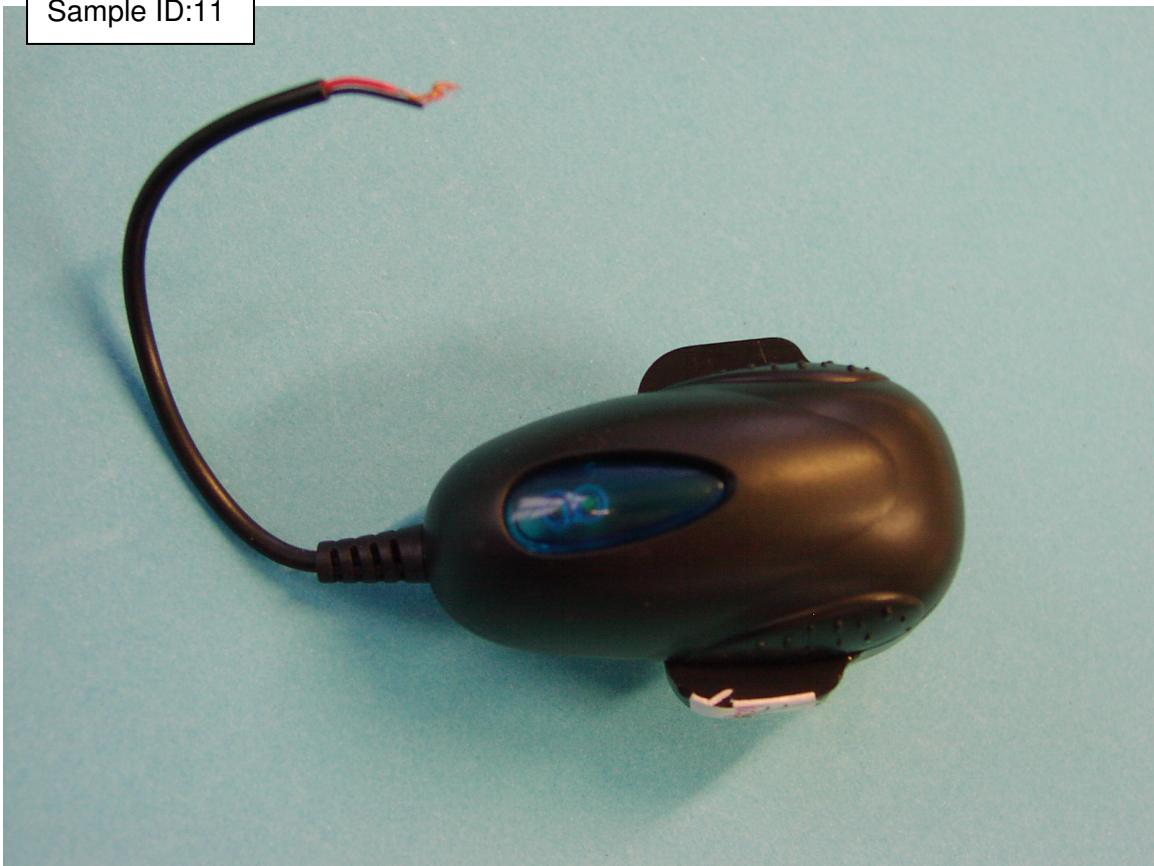
Sample ID:11

As received observations: Unit not functioning – no output voltage.

The unit met the dielectric strength test requirements of this clause with  $3,640\text{V}\sim$  applied between hazardous live parts and the power supply body with no breakdown. However with the dielectric strength test applied between input and output circuits, the insulation broke down at  $2,000\text{V}\sim$ .

The submitted power supply unit ID11 failed to meet the requirements of the clauses tested, as detailed above.

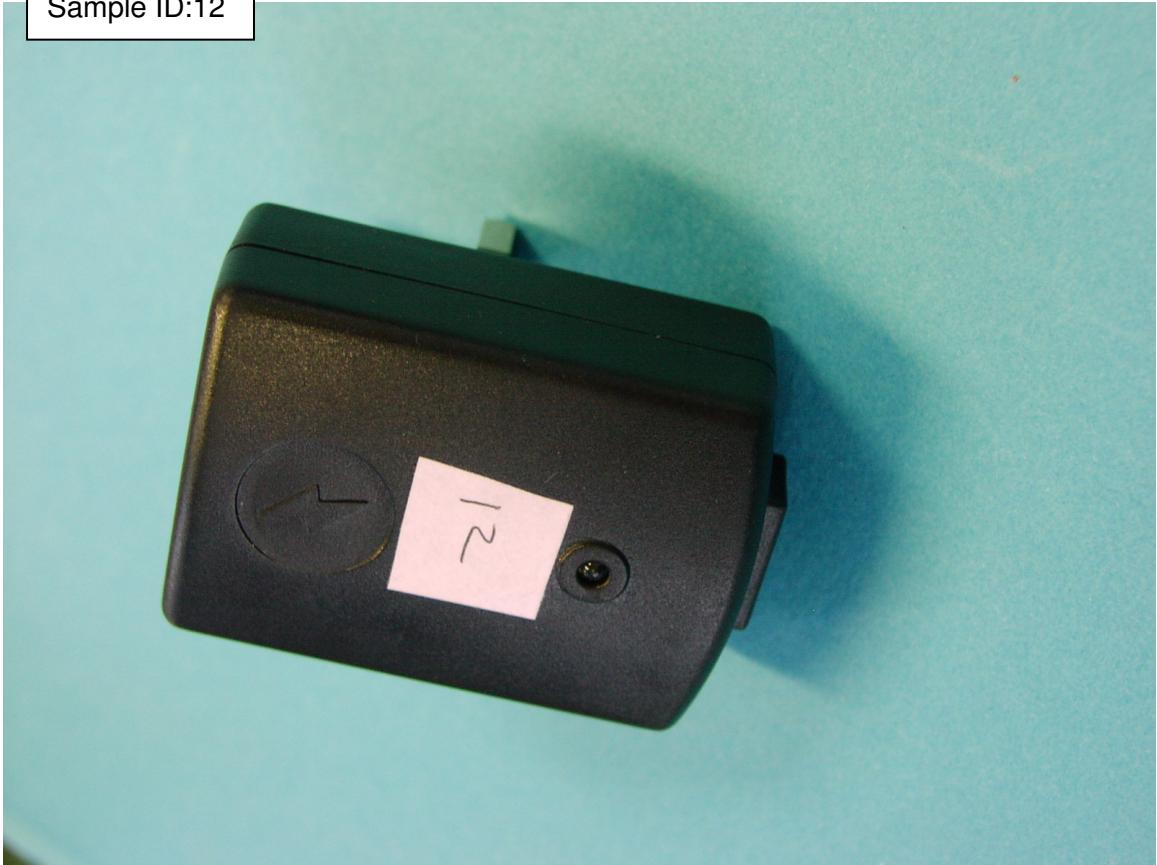
Sample ID:12

The unit met the dielectric strength test requirements of this clause with 3,640V~ applied between hazardous live parts and the power supply body with no breakdown. However with the dielectric strength test applied between input and output circuits, the insulation broke down at 2,000V~.

The submitted power supply unit ID12 failed to meet the requirements of the clauses tested, as detailed above.

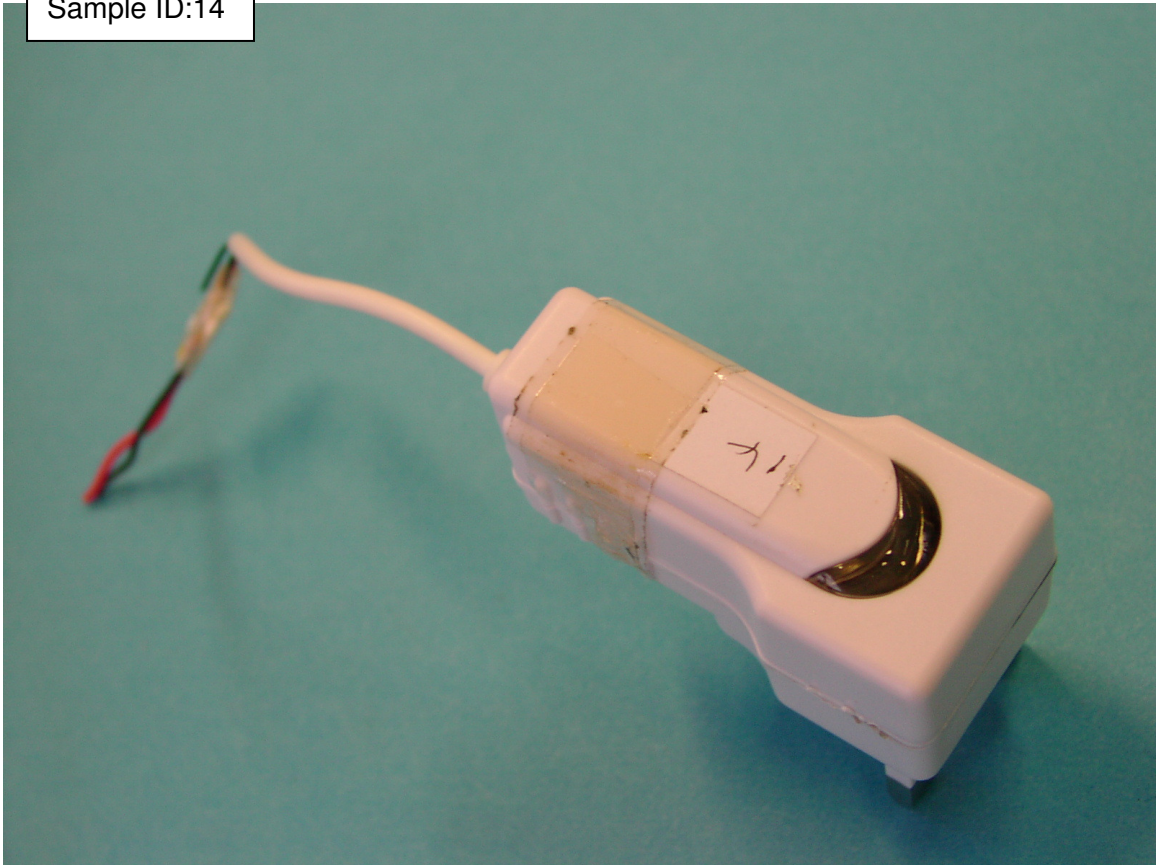
Sample ID:14

The unit met the dielectric strength test requirements of this clause with 3,640V~ applied between hazardous live parts and the power supply body with no breakdown. However with the dielectric strength test applied between input and output circuits, the insulation broke down at 2,000V~.

The Live and Neutral wires connecting the PCB to the plug pins were attached to the plug pins by solder only, with no secondary securement. Should a wire break free, its movement could result in a hazardous mains voltage being applied to the low voltage secondary circuit.

Following short circuit of the output, component damage within the power supply was observed. The capacitor across the barrier primary to secondary is marked '102 1kV' – no other marking was present, this is required to be a Y1 capacitor.

The submitted power supply unit ID14 failed to meet the requirements of the clauses tested, as detailed above.
