## **Safety Screening Report**

**Report:** 071-75924520-402 **Date:** 09/01/2014

**Product:** Electrical Socket **ESC Sample** 2

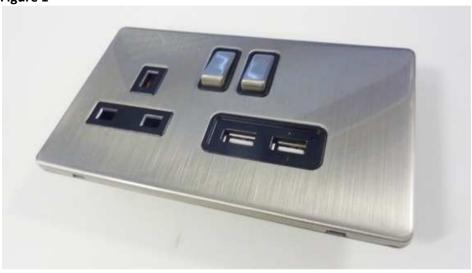
Figure 1

**Summary:** TÜV SÜD Product Service was commissioned by The Electrical Safety Council to

evaluate an Electrical Socket (see figure 1). The aim of the assessment is to assess the

The product was of adequate external construction. Internal construction was poor and the product failed the provision for earth and the creepage and clearance tests. Several markings were also missing from the product.

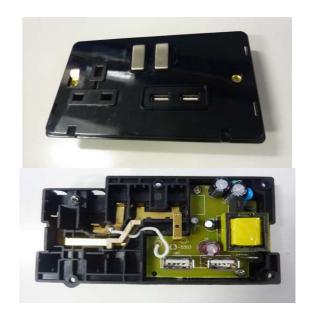
**Internal Overview**

Constructional Quality	⊠-Pass □-Fail		
Comments	The switches, internal conductors and USB sockets were adequately retained within the internal structure of the back cover. This was then secured by a riveted earthing conductor which acted as a brace around it. The connections (conductor / wiring) to the PCB were mechanically secured and soldered in place.  The tracks on the secondary side of the PCB had been built up with additional solder. It is considered that this was done to ensure the track could withstand the flow of the current; however this method is not considered good practice.		
Creep	page Distances, Clearances & Distances Through Insulation (BS EN 61558-1, Clause 26)		
Constructional Quality	☐-Pass ☐-Fail		
Comments	The minimum creepage / clearance distance measured between the primary and secondary sides of the circuit board (1.9mm) was outside the limit specified by the standard. A minimum of 5mm is required.
